Tesla, Inc.
Service Bulletin

Inspect and Replace Rear Lower Control Arms

SB-25-31-002

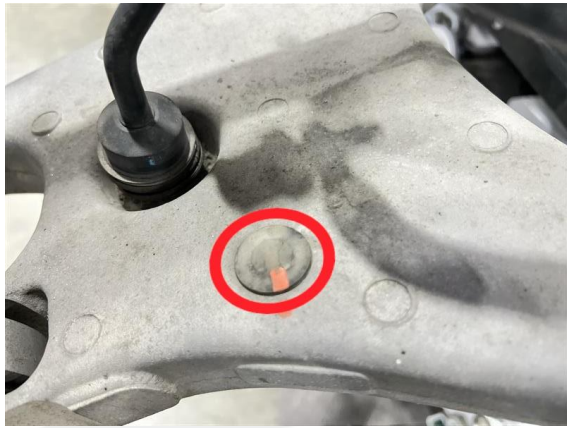
Figure 1 – LH

1. Remove the upper plugs (x2) from both rear lower control arms (Figures 1 and 2).

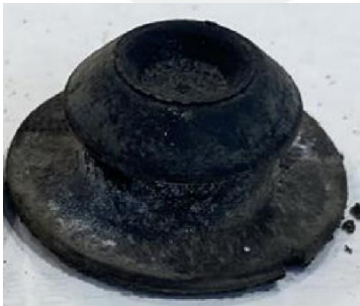
2. Inspect the plugs (x2) for signs of water leakage and salt deposits (Figures 3–5).

Figure 3 – Pass

- If the plugs on both rear lower control arms show no signs (Figure 3) or minimal signs (Figure 4) of water leakage or salt deposits, skip to step 3.
- If the plug(s) on one or both rear lower control arms show signs of excessive salt deposit or rust, skip to [Replace Rear Lower Control Arms](#).

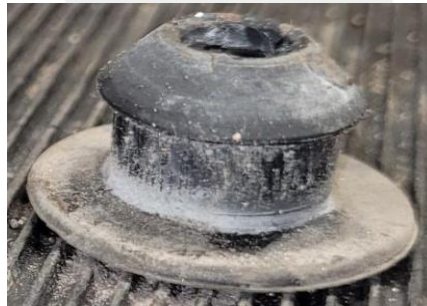
Figure 4 – Pass:
Limit of allowable salt deposits

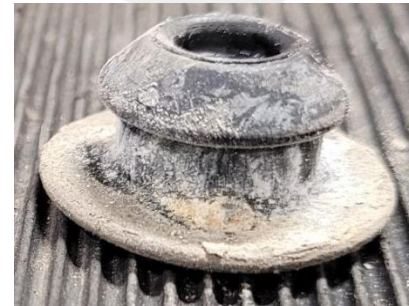
Figure 5 – Fail

Replace the LH and RH rear lower control arms (refer to Service Manual procedure 31031102; [Model S](#), [Model X](#)).

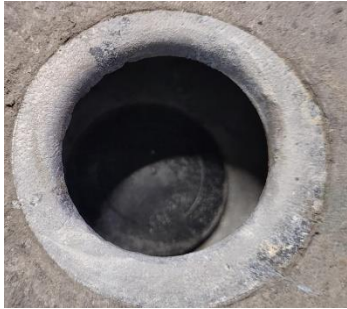
3. Use an inspection mirror and work light to inspect the plug holes in the casting of the rear lower control arms for signs of rust or water ingress (Figures 6–8).

Figure 6 – Pass

- If the holes in both rear lower control arms show no signs of rust, salt deposits, or water ingress (Figure 6), install new replacement plugs, and then discontinue this procedure. Use correction code S022531002.
- If new replacement plugs are not available, skip to [Replace Rear Lower Control Arms](#).
- If the hole(s) in one or both rear lower control arms show signs of rust or salt deposits (Figure 7), and/or evidence of water ingress (Figure 8), skip to [Replace Rear Lower Control Arms](#).

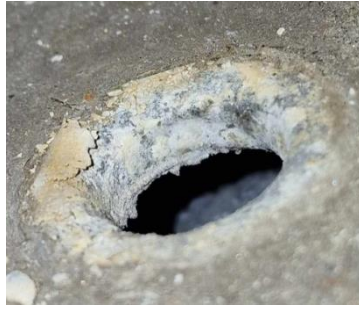
Figure 7 – Fail

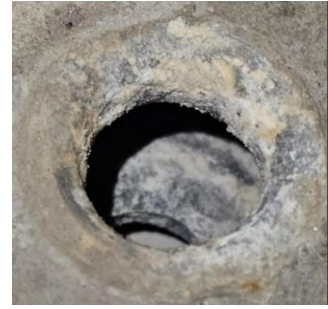
Figure 8 – Fail
